HOUSATONIC RIVER BASIN
SALISBURY, CONNECTICUT

**SOUTH POND DAM
CT 00592**

**PHASE I INSPECTION REPORT
NATIONAL DAM INSPECTION PROGRAM**

MAY 1979

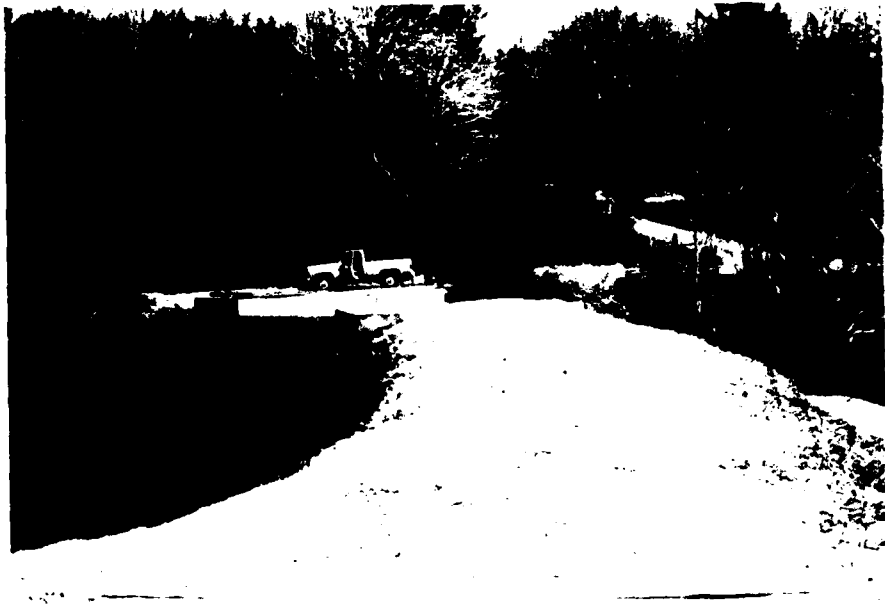
PHOTO NO. 21 - Station 2+00, crest of dam at centerline looking toward left side.
